CAP Aviation 9, rue de l'Aviation 21121 DAROIS - France Tel +33 380 35 65 10 Fax +33 380 35 65 15 www.capaviation.com		<b>S E R V I C E B U L L E T I N</b>
<b>NUMBER</b>	<b>TITLE</b>	<b>ATA SYSTEM</b>
000202	Starter relay	80

## 1. PLANNING INFORMATION

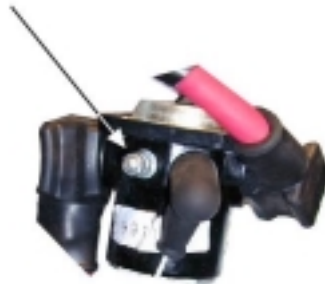
UNUSED CONNECTOR

Some recent aircraft equipped with Cessna starter relay part number S-1991A1 have experienced problems in service. 2 types of problem were identified :

- ❖ Relay stay connected while starter button is released
- ❖ Relay get connected during flying while flying aerobatics maneuvers

1. Disconnect the 3 wires from the starter relay S-1991A1
2. Remove and discard the original starter
3. Put in place the new starter relay
4. Connect the 3 wires on the new relay, isolate the unused connector with a thermo-shrinkable tubing of 9 or 10 mm (0.35 or 0.39 in.) (see picture below)
