CAP Aviation 9, rue de l'Aviation 21121 DAROIS - France Tel +33 380 35 65 10 Fax +33 380 35 65 15 www.capaviation.com	<b>S E R V I C E   B U L L E T I N</b>	
<b>NUMBER</b>	<b>TITLE</b>	<b>ATA SYSTEM</b>
010301	Canopy handle	56

Inform users about canopy handle replacement and new parts references.

Present Southco handle (reference: 92-42-531) replacing CAP10-10-19-06B.

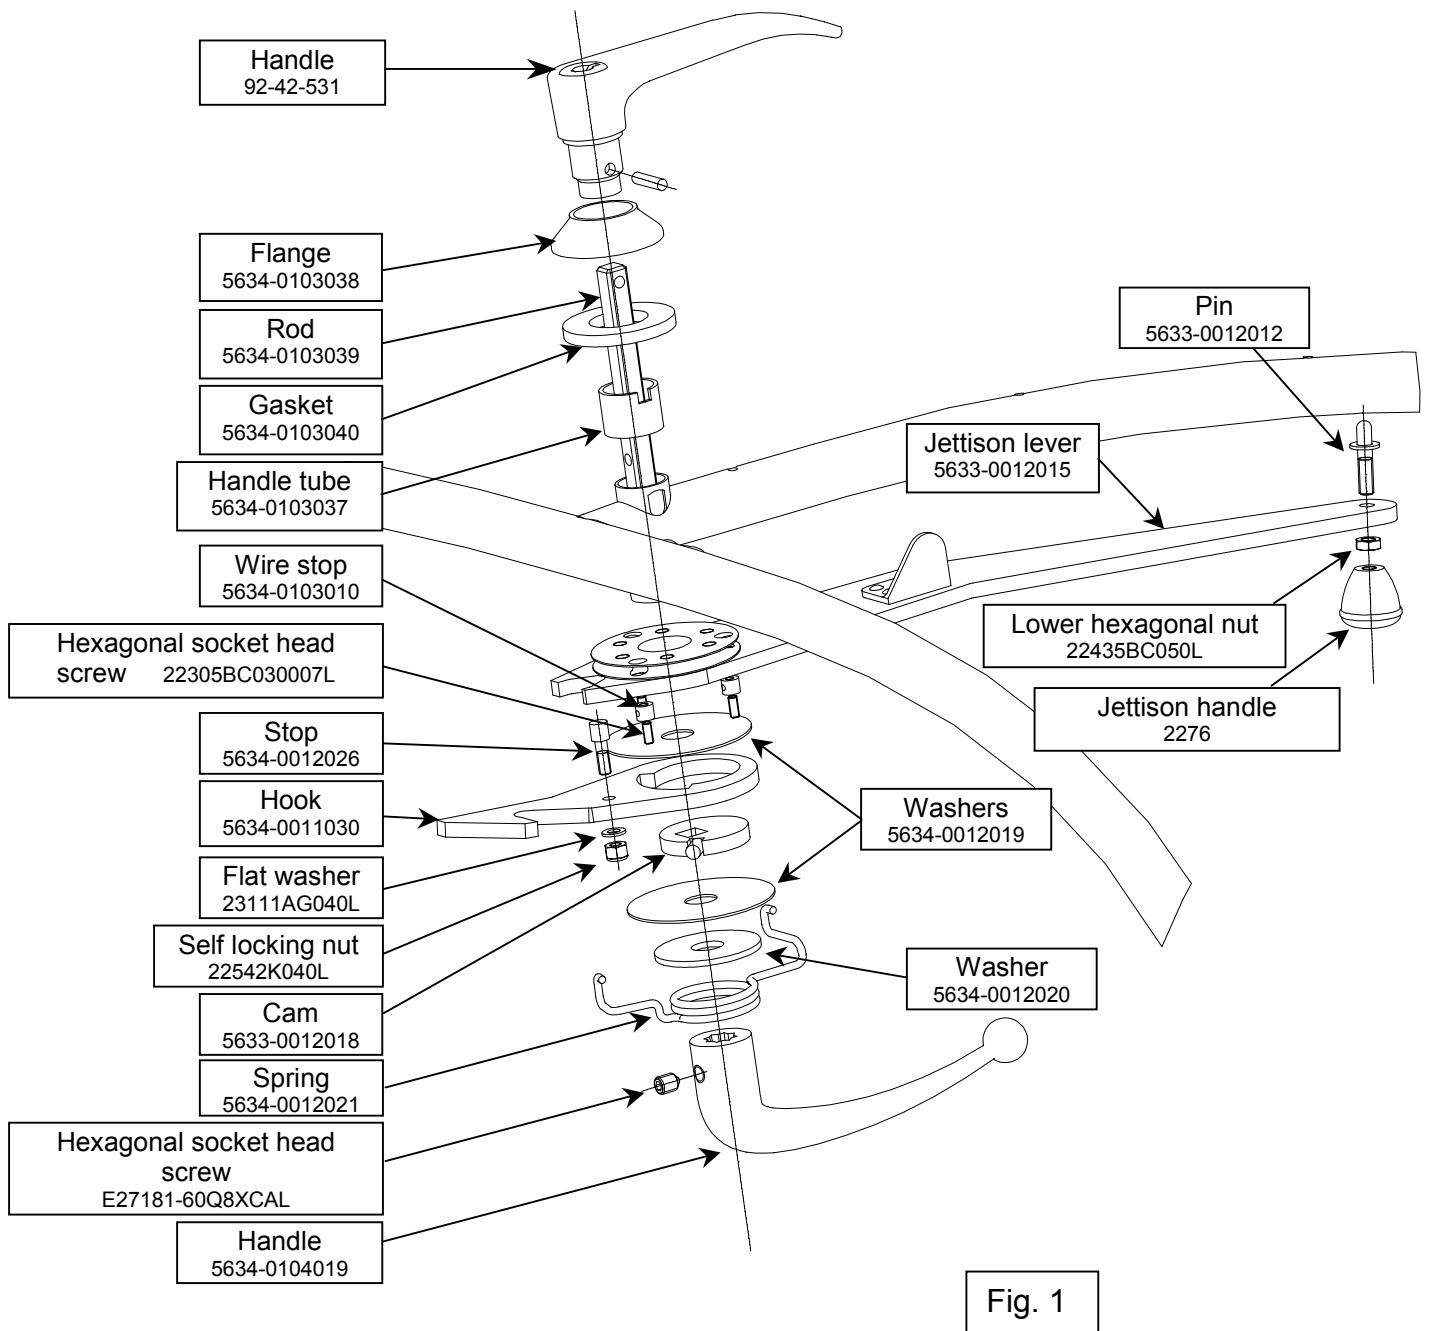
### 2.1 Description

- Install handle inserting new parts (refer to figure 1).
