SERVICE BULLETIN n°980901

ATA SYSTEM : 27
EFFECTIVITY : CAP231ex - 232
TITLE : Trim tab control axis

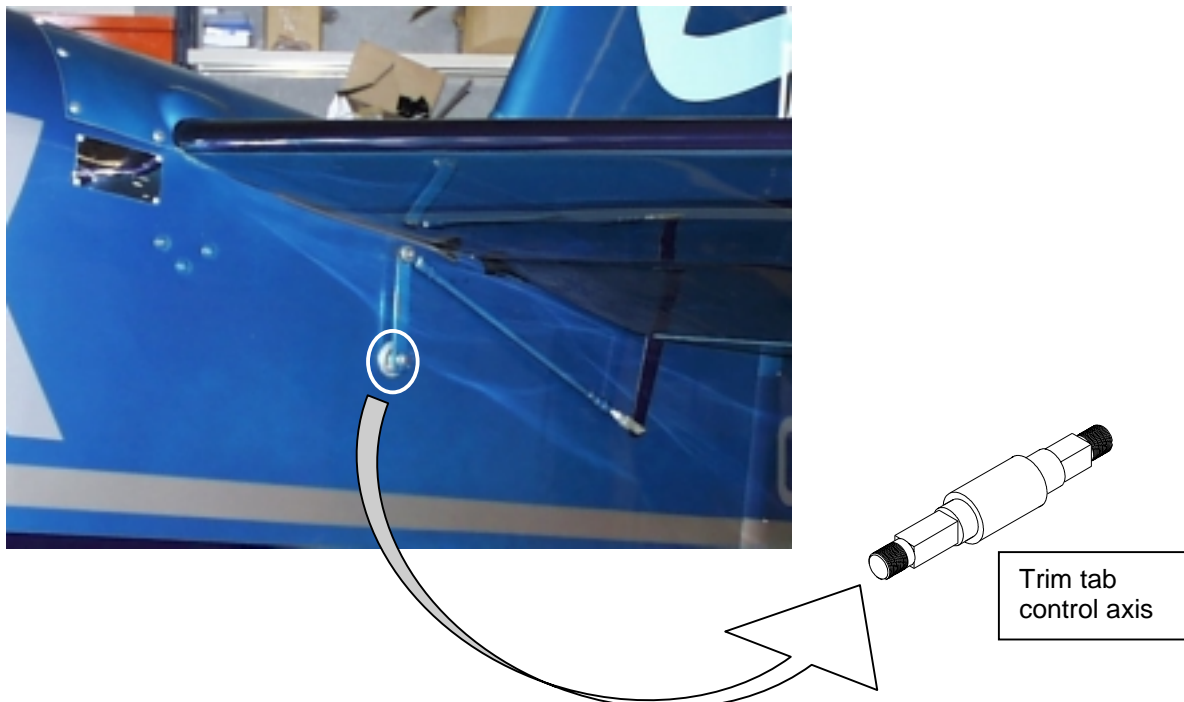
To guaranty the reliability of the trim tab control axis after the incident n°001/98/AKROTECH reported on the 05/07/98 by the GSAC Dijon.

To limit the life of the part at **400 hours**.

New P/N	Quantity	Unit list price	Key word	Old P/N	Instructions
2734-9220401	1	260 FHT	Trim tab control axis	2734-9220401	Life limit at 400 hours
