SERVICE BULLETIN n°990201

ATA SYSTEM : 56
EFFECTIVITY : CAP10B
TITLE : Canopy locking hook

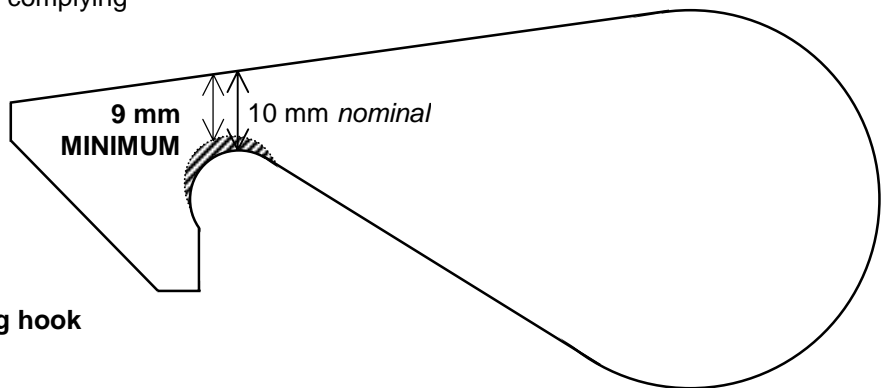
Figure 1 : Canopy locking hook

The locking hook failure appears after an excessive filing of the tumbler. It is sometimes necessary to modify this part in order to adjust the installation of a new windshield.
The material quantity left on the locking hook must be at least of 9 mm (0.35 in) minimum.
This measure is accompanied with an inspection of the part.

- A. Check the hook (located #49 on the 15B planch of the Parts catalogue)
- B. The tumbler depth must not be so that material quantity left is **9 mm (0.35 in) minimum**
- C. Replace the part if non complying

- A. Check visually the canopy locking hook each **50 hours inspection**
